Contract #: 04-0120F4Cty: SF/ALA Rte: 80 PM: 13.2/13.9File #: 69.28**WELDING INSPECTION REPORT****Resident Engineer:** Siegenthaler, Peter**Address:** 333 Burma Road**City:** Oakland, CA 94607**Report No:** WIR-018461**Date Inspected:** 01-Dec-2010**Project Name:** SAS Superstructure**OSM Arrival Time:** 700**Prime Contractor:** American Bridge/Fluor Enterprises, a JV**OSM Departure Time:** 1900**Contractor:** Zhenhua Port Machinery Company, Ltd (ZPMC), Changxing Island **Location:** Shanghai, China**CWI Name:** Li Yang**CWI Present:** Yes No**Inspected CWI report:** Yes No N/A**Rod Oven in Use:** Yes No N/A**Electrode to specification:** Yes No N/A**Weld Procedures Followed:** Yes No N/A**Qualified Welders:** Yes No N/A**Verified Joint Fit-up:** Yes No N/A**Approved Drawings:** Yes No N/A**Approved WPS:** Yes No N/A**Delayed / Cancelled:** Yes No N/A**Bridge No:** 34-0006**Component:** OBG Segments**Summary of Items Observed:**

On this date Caltrans OSM Quality Assurance (QA) Inspector, Dan Hernandez was present during the times noted above to observe the fit up, welding and related activities associated with the fabrication of the San Francisco Oakland Bay Self Anchored Suspensi

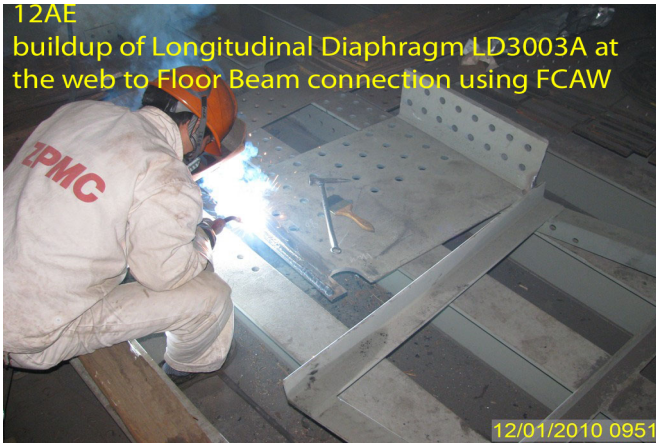
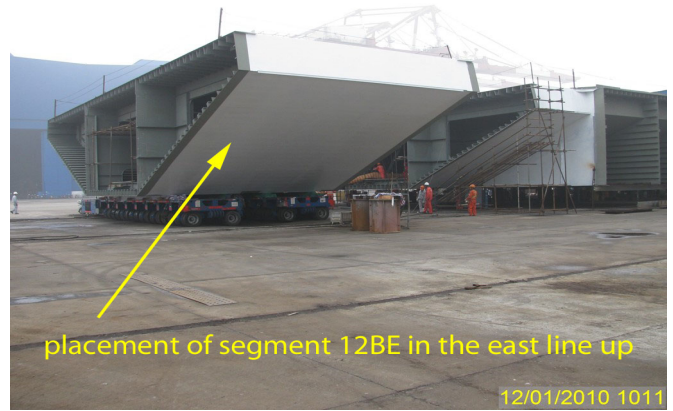
This QA Inspector observed Flux Cored Arc Welding (FCAW) in progress the buildup of Longitudinal Diaphragm LD3003A at the web to Floor Beam connection. The welder is identified as #047353 and was observed welding in the 2G (horizontal) position using approved Welding Procedure Specification WPS-345-FCAW-2G (2F)-ESAB-repair for WR17894.

This QA Inspector observed Base Metal Repair using the Shielded Metal Arc Welding (SMAW) process at locations of gouges in the beveled edge of the Bottom Plate at 12AE/12BE transverse CJP splice. The welder is

This QA Inspector observed the back gouging of the root pass on the Side Plate to Bottom Plate hold back CJP splice, cross beam side.
